Case Study

**Termination fault prevented: Large Industrial Chemical Plant, South Korea
May 2016**

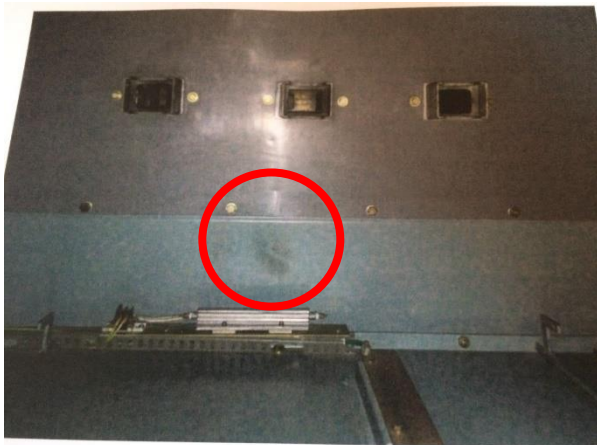
The customer confirmed that an onsite investigation was conducted and carbonisation was found in the panel next to a heater. The heater is used to keep the surrounding environment dry, however some carbonisation from the heater had started to conduct the electricity and was short circuiting. If carbonisation is present anywhere in the area, it increases conductivity and therefore decreases insulation properties.

The images below show obvious signs of surface tracking and burning from the carbonisation. The customer believes that arcing was occurring in this area.

Inside panel where the heater was causing the carbonisation

IPEC recommended that the network be taken offline immediately in order to replace the faulty termination. The customer conducted the repair and put the system back online.

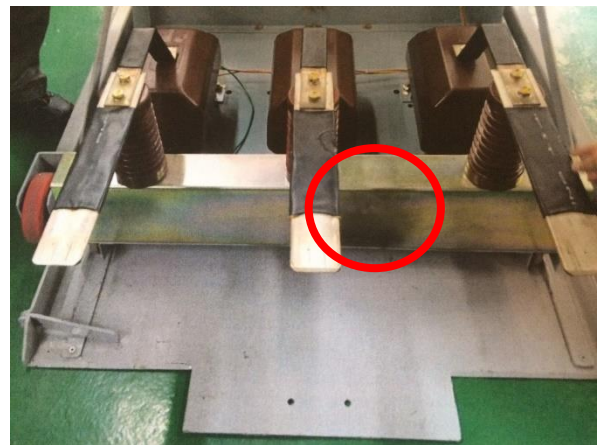
Carbonisation seen from arcing

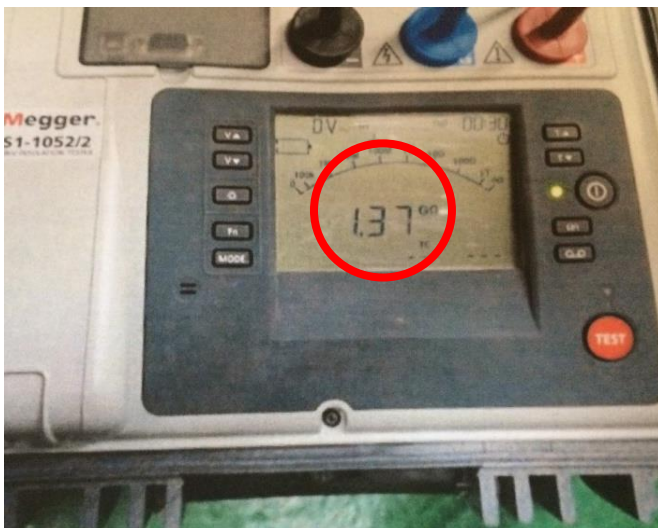
Some tests were conducted using Megger equipment to compare results before and after the repair. The Megger device is attached onto the outside of the insulation and 11,000 volts is put through it. The instrument then measures the resistance value, the higher the value the higher the resistance there is and hence there is less chance of a short circuit. Before the repair was conducted the instrument gave a reading of 1.3Ω , which is a very low resistance reading after an injection of 11,000 volts. This means that the resistance was very low and the insulation is compromised. After the repair the Megger reading showed 447Ω which means that the resistance was over 300 times more efficient, see images below.

Results before the repair was taken out

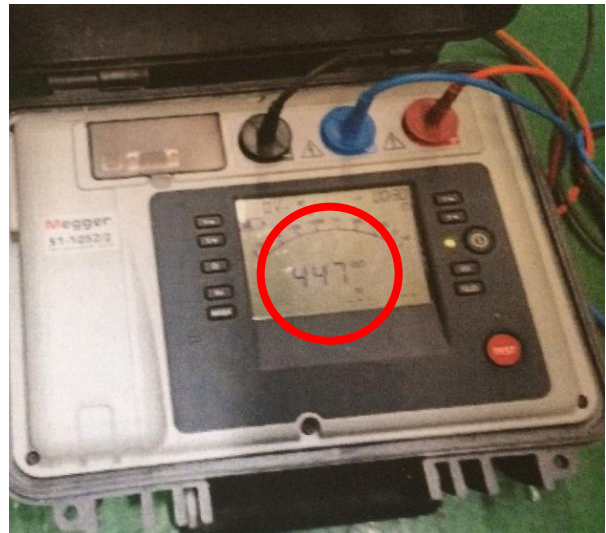
Results after the repair was taken out
